# **Reports on Environmental Sciences 9**

# TESTING LOW-ALTITUDE INFRARED DIGITAL PHOTOGRAPHY FROM A MINI-UAV TO RETRIEVE INFORMATION FOR BIOLOGICAL CONSERVATION

Agustín Lobo¹
APÈNDIX A L'INFORME CORRESPONENT A L'ESTUDI
PLANIFICACIÓ DE LA CAMPANYA D'ADQUISICIÓ D'IMATGES EN INFRAROIG PROPER DE
BAIXA ALÇÀRIA SOBRE ZONES D'INTERÈS AL MONTSENY
Exp.2008/0005216. Op. 8030003304. A1200-22709

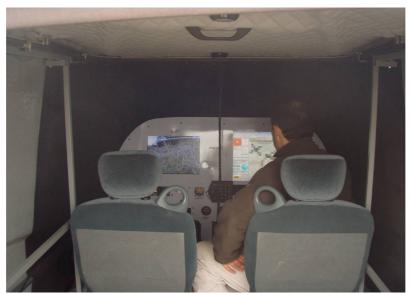
Figure 4. Inside view of the Control Cabin

The control cabin, mounted as an small trailer, is common to all CATUAV platforms and replicates a regular cabin of an small airplane, with seats and displays for pilot and co-pilot. Pilot screen diplays real-time video acquired by the navigation camera, while co-pilot screen displays a navigation program to control the position of ATMOS-3 over a map or ortho-image. Power for the control cabin is provided by batteries and an electrical generator. Location of the control cabin must be planned ahead of time to avoid obstacles preventing appropriate control. Pre-programmed flight is possible, and in this case the maximum 15 km range can be exceeded.

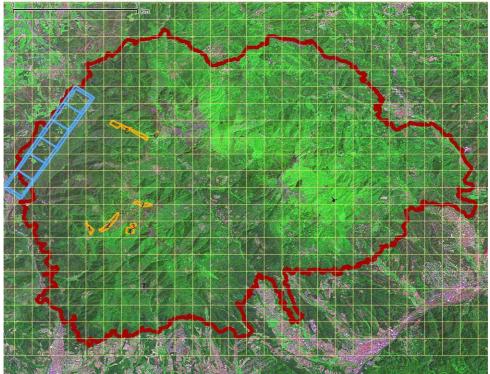
Figure 6. Area of Study

The flight line acquired by ICC was located at the western part of the Parc Natural del Montseny (PNM), the first goal for the CAT-UAV campaign being to acquire images matching a sufficient proportion of the ICC imagery as to compare both types of images. PNM staff included an additional number of areas of interest, of which only the one nearest the ICC overflown area could be attended.

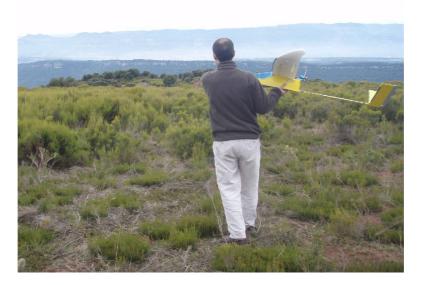
Figure 12. ATMOS-3 operated in the field

CATUAV personnel deployed their equipment promptly and efficiently, being able to move their small trailer through the main trails of the PNM. The site for the control unit was selected in a short time and the UAV was not only able to fly according to the flight plan but it was also possible to include additional sites as suggested by the navigation camera during operations.

The UAV was able to take off and land on a heatherland. Meteorological conditions were near the worst limit for operation, for which results from this campaign can be considered on the lower bound of quality available from this system.

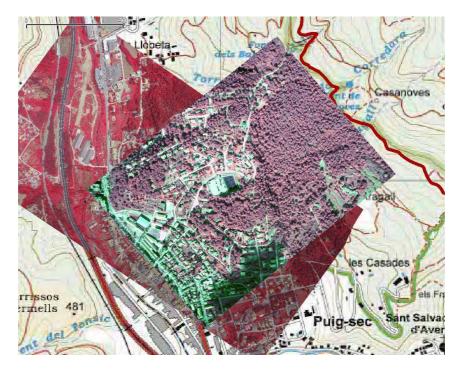
Figure 20. Effect of radiometric standardization to the DMC Reference Image using pseudo-invariant

objects. DMC acquired by ICC (0.1 m resolution) and CATUAV image overlayed. CATUAV image (height 1174 m above ground, 0.399 m resolution) is positioned using navigation information only, and its georeferencing is thus only approximate

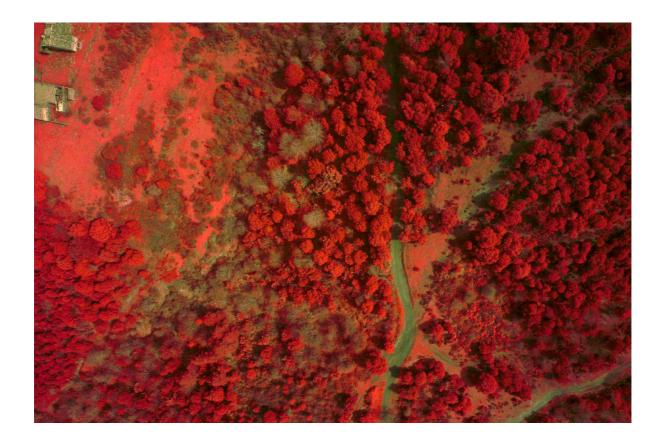
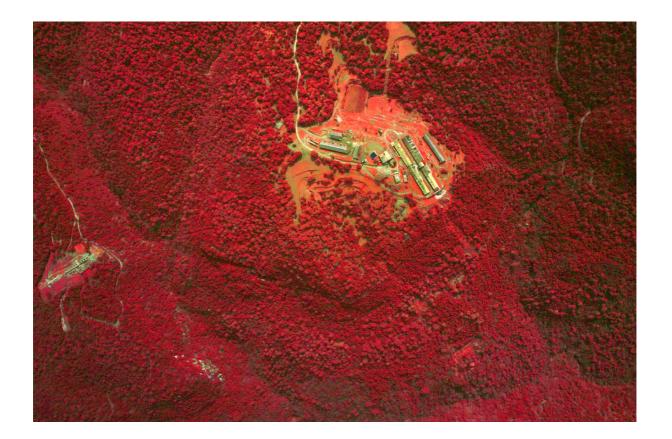
The recent development and test of VEGCAM-PRO on board ATMOS-4 (an improved ATMOS able to carry a payload up to 400 g) represents a significant step towards reducing many of the insufficiencies noted in the previous repport and puts in evidence the engagement of CATUAV on continously improving their systems. VEGCAM-PRO is a completely different camera, based on a 14 Mp FOVEON image sensor instead of a CMOS, which results on images of notorious quality both in terms of sharpness and color intensity. We will conduct a more in-depth analysis of these images shortly, by now just reproduce some of them.
