Museum's floating exposition: The Fishing Boats [1,2]

Elaborate a Pest Management Proposal within the Integrated Pest Management framework, keeping:

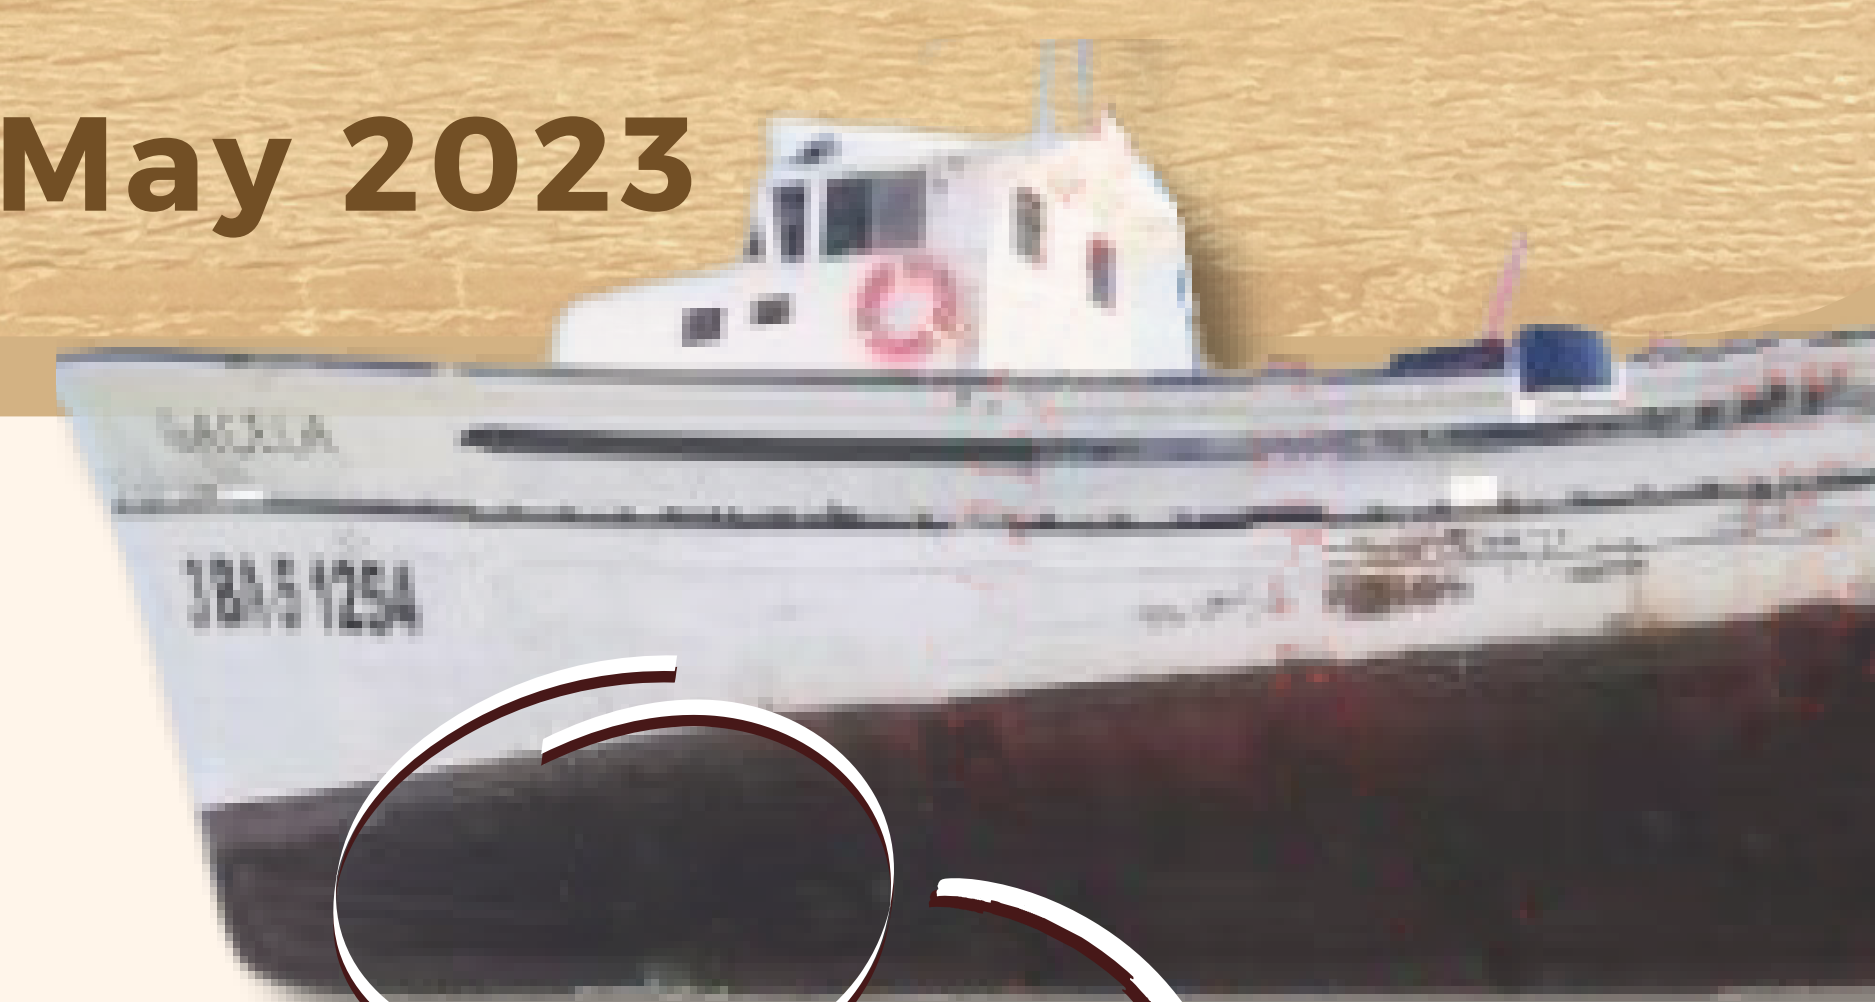
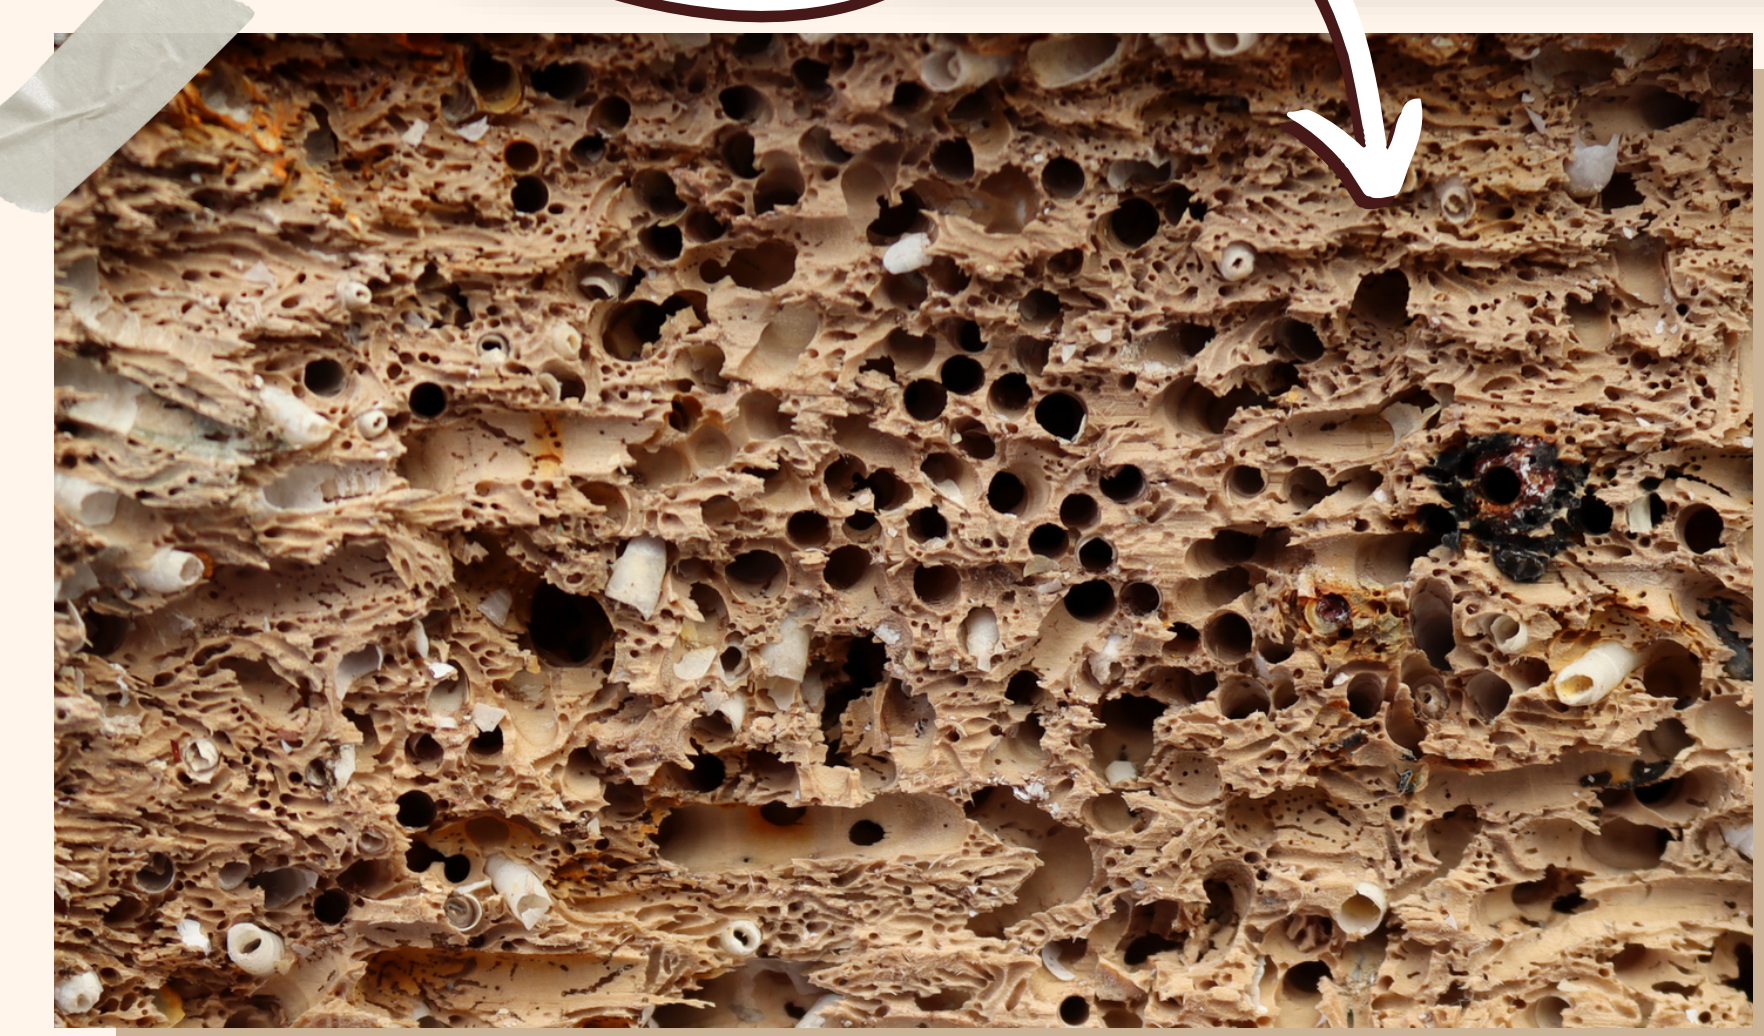
- Built in 1960.
- *Pinus pinea*, *Quercus* spp. & *Milicia excelsa* wood.
- 20.2 x 5.2 x 2.4 m.
- Dry dock every 4-5 years.
- Hull ↑↑ affected by the pest.

- Built in 1970.
- *Pinus pinea* & *Quercus* spp. wood.
- 14.7 x 5.13 x 1.5 m.
- Dry dock every 2-3 years.
- Hull ↓↓ affected by the pest.

60% of hull reparations are associated with Marine Wood Borer damage

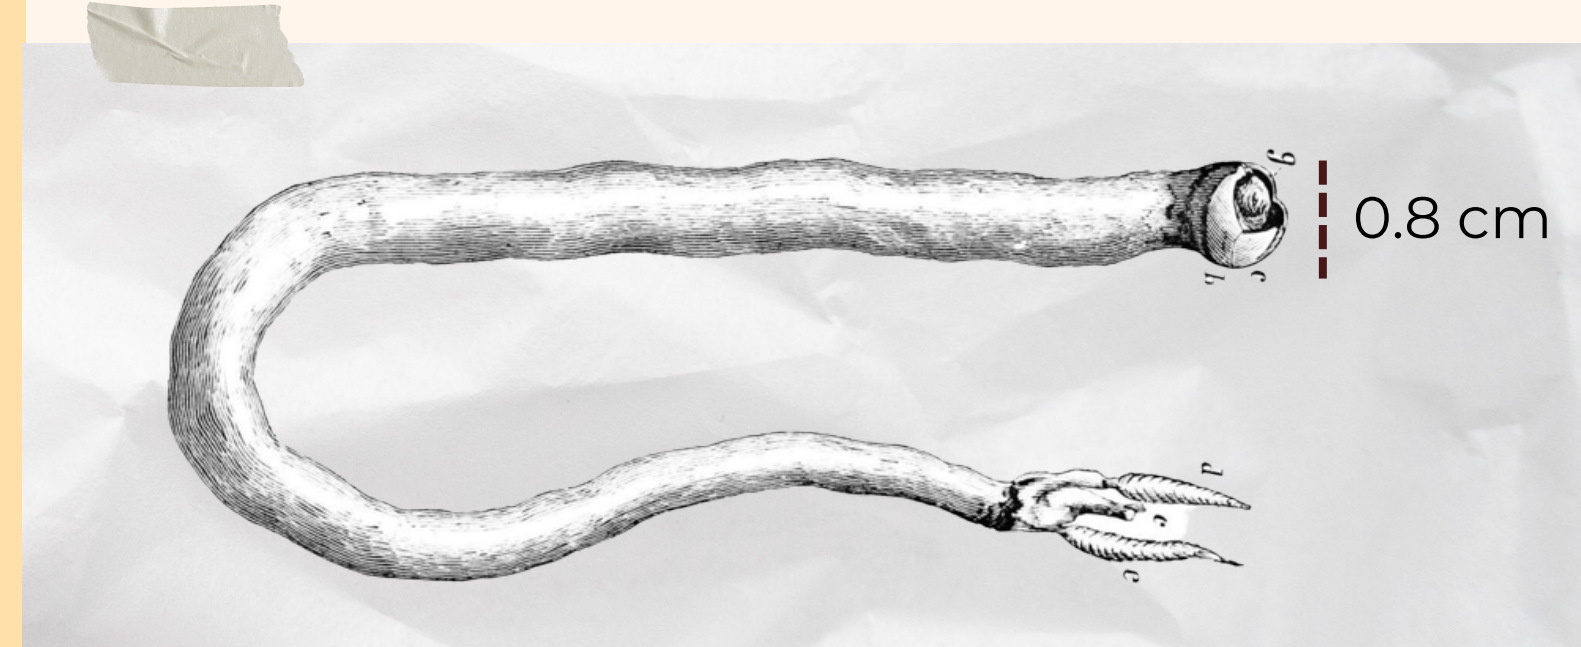
Teredinidae [3]

- Larval dispersal stage, modified adult form.
- ↑ distributed, 8 spp. in the Mediterranean Sea.
- Most known sp.: *Teredo navalis*.
- Δ T & salinity range.
- ↑ impact on wood.

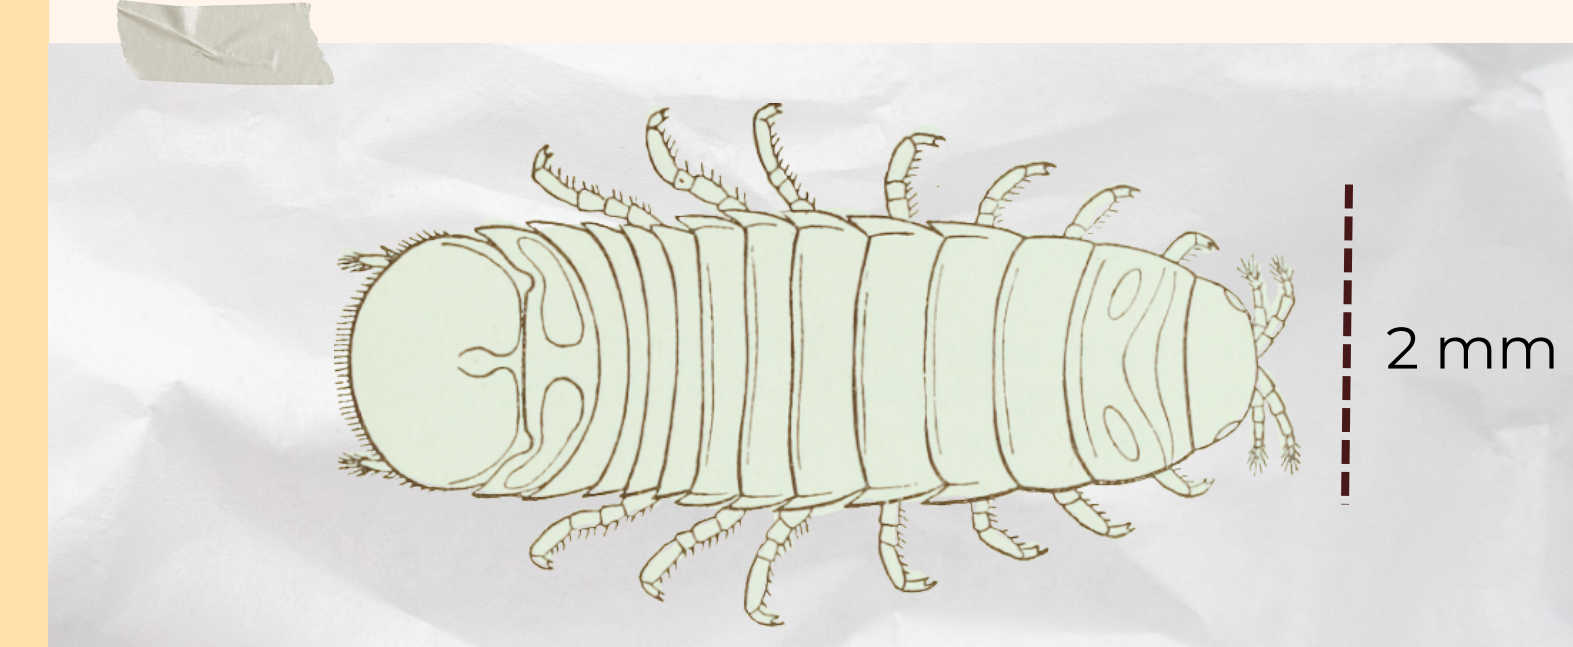
Limnoriidae [4,5]

- Adult dispersal stage.
- 2 *Limnoria* spp. in the Mediterranean Sea:
 - *L. tripunctata*
 - *L. quadripunctata*
- ↑ T & salinity range.
- ↑ impact on wood.

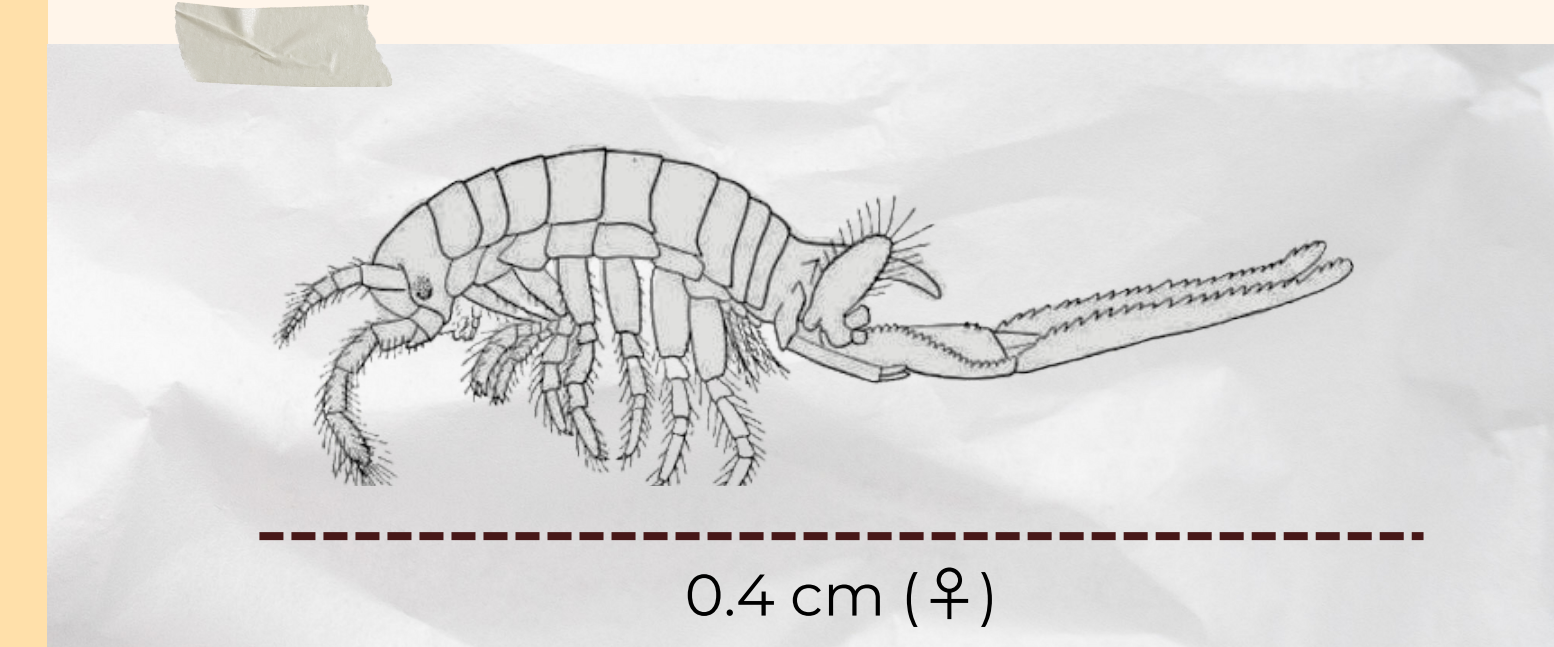
Cheluridae [6]

- Adult dispersal & colonising stage.
- 1 sp. in the Mediterranean sea: *Chelura terebrans*.
- ↑ T & salinity range.
- *Limnoria* spp. comensal → ↓ impact on wood.

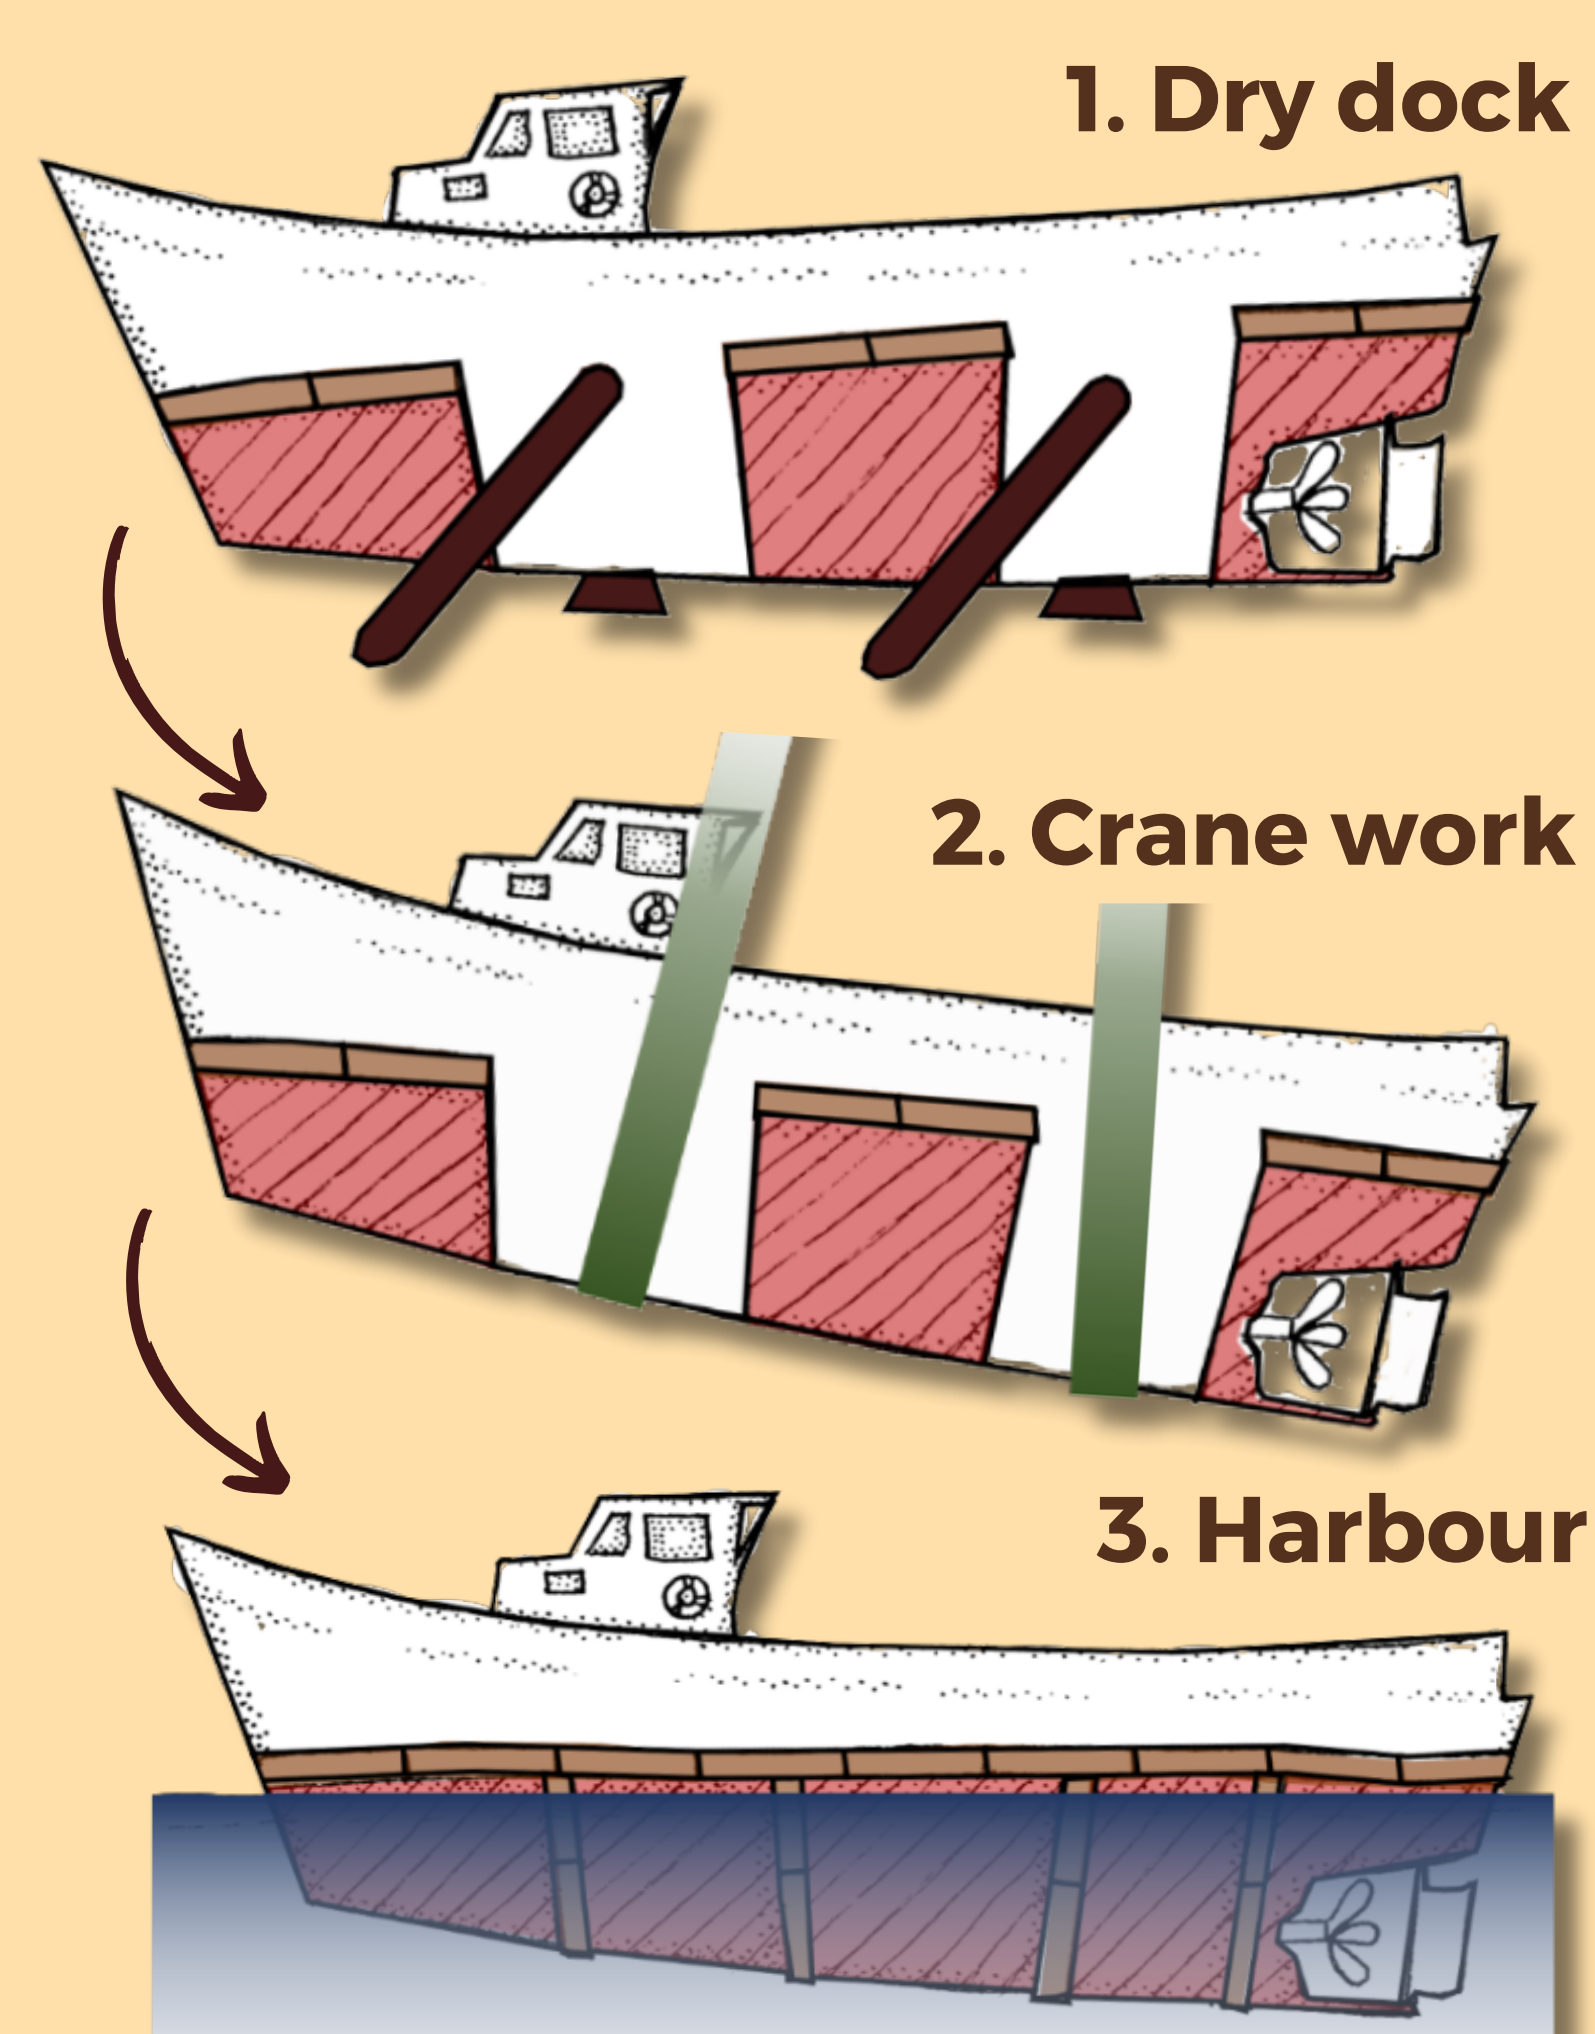
Application

Op. 1 & 3: dry dock or **hybrid application**.
Op. 2: dry dock.

Plastic coating (red) & wood slats (light brown) are placed in the **bow**, **stern** and the **hull central area**, leaving sections with support structures (dark brown) free.

The boat is taken into water placing **slings** (in green) in the **plastic coating-free** sections, avoiding damage in protected hull areas.

Plastic coating left is applied in water, placing **wood slots** between sections to guarantee no areas are exposed to water & consolidate the structure. A **water extractor pump** should be used & installed.

Repeat every time boats are taken to dry dock.
2-3 people team, ~5h work.
