Carabassa, Vicenç; Ortiz Perpiñà, Oriol; Alcañiz, Josep M. «RESTO-  
QUARRY: indicators for self-evaluation of ecological restoration in open-pit  
mines». Ecological indicators, Vol. 102 (July 2019), p. 437-445. DOI  
10.1016/j.ecolind.2019.03.001

1 **Title: RESTOQUARRY: indicators for self-evaluation of ecological restoration in**  
2 **open-pit mines**

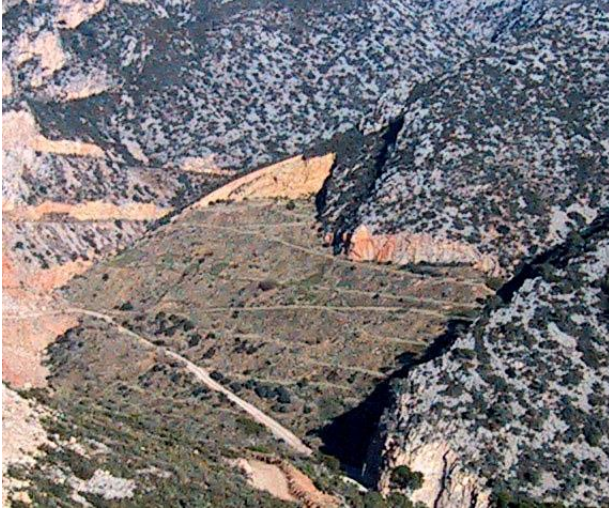
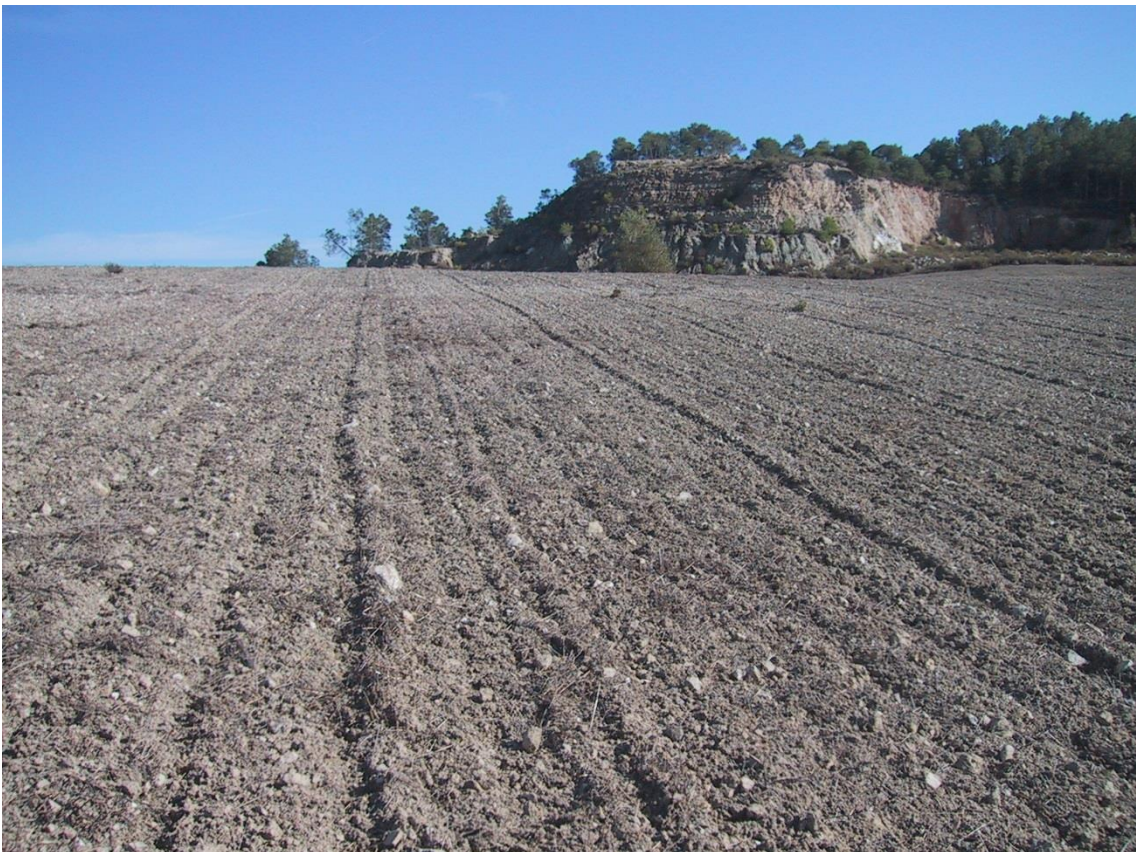
656 Figure 3. Differences in vegetation type between restored zones and surrounding areas  
657 (left), and the presence of artificial morphologies, like walls (cliffs) in flat/hilly  
658 landscapes (right), that make the integration of the restored areas to the landscape  
659 difficult.

236 Regarding chromatic and morphologic integration to the surrounding landscape, the  
237 majority of the evaluated restorations (93%) present good results. However, in some  
238 cases, the presence of artificial morphologies (cliffs in hilly landscapes, isolated tips, or  
239 repetitive and linear slope-berm morphology) and the dominance of herbaceous  
240 vegetation in a site surrounded by forests make this integration difficult (figure 3), at least  
241 in the first stages of restoration.

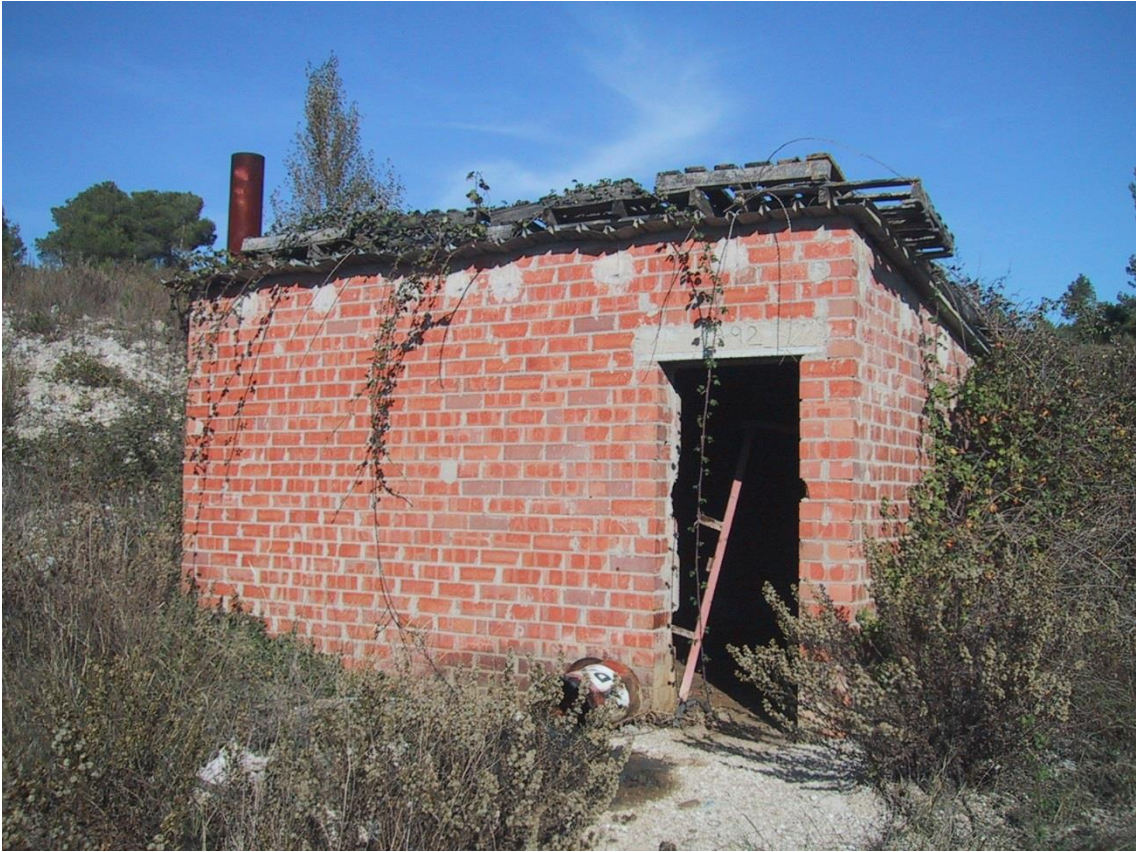
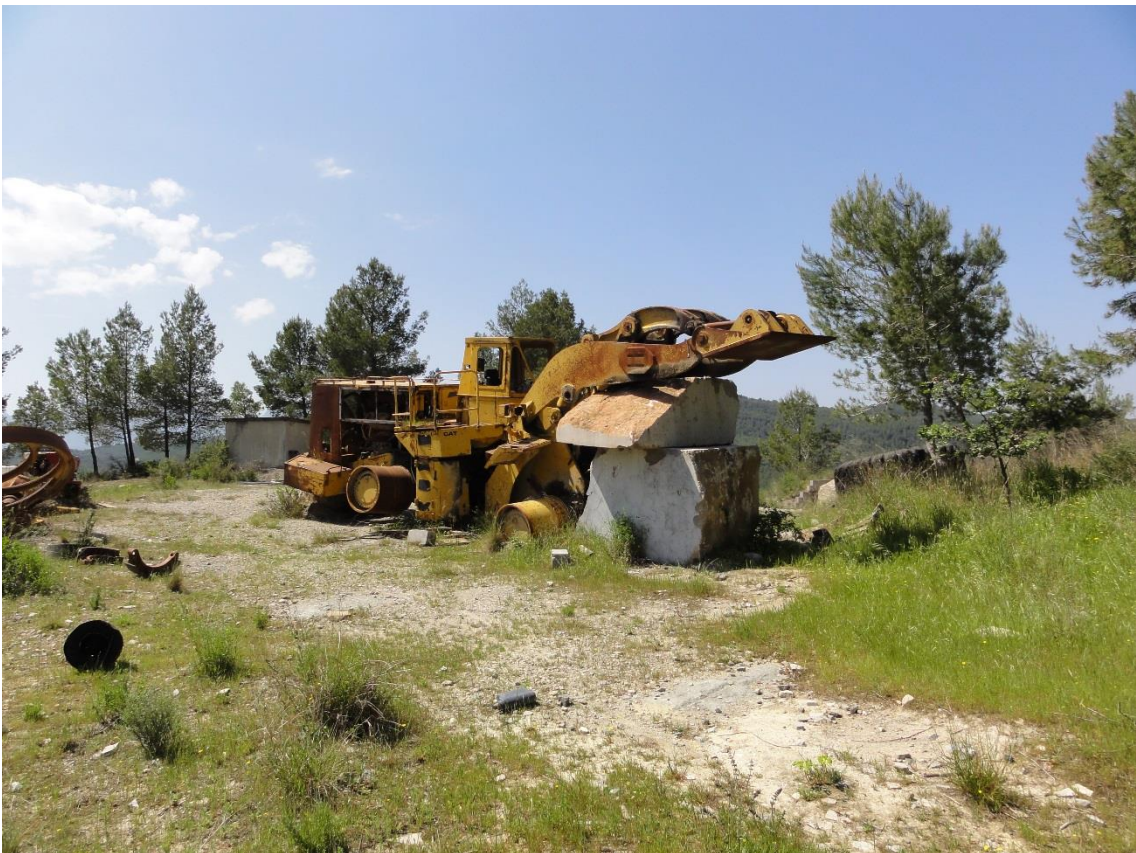
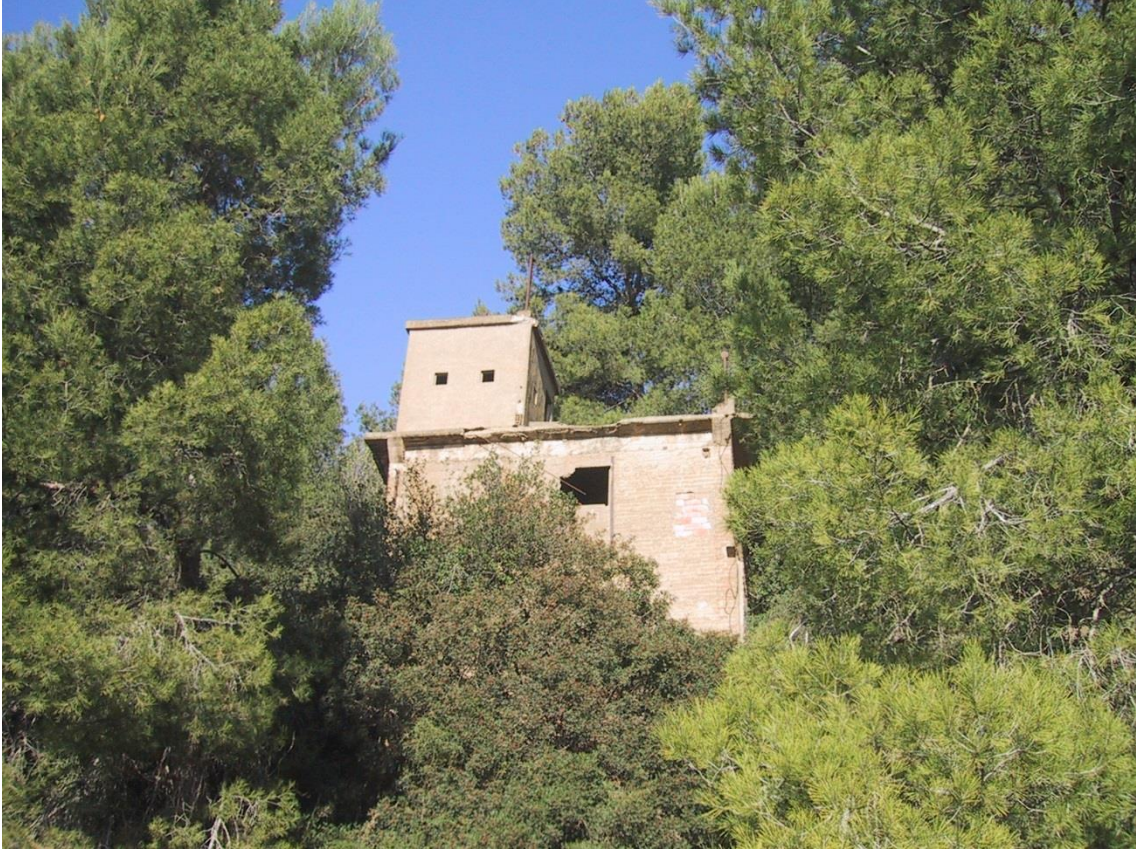
663 Figure 4. The presence of abandoned buildings and machinery of the former extractive  
664 activity has a negative impact on the integration of the restored areas and represents a risk  
665 for people.

253 Approximately 1/3 of the areas were affected by anthropogenic impacts of various types.  
254 The most common effects were related to dumping, mainly in quarries located near to  
255 urban areas, and to the presence of abandoned infrastructures and machinery (i.e. ruins of  
256 buildings, sheds, conveyor belts or old bulldozers and dumpers) from the previous mining  
257 activity (Figure 4).
