Title: Development of a dairy fouling model to assess the efficacy of cleaning procedures using alkaline and enzymatic products

Article Type: Research paper

Keywords: Dairy fouling; cleaning; enzyme; Maillard reaction

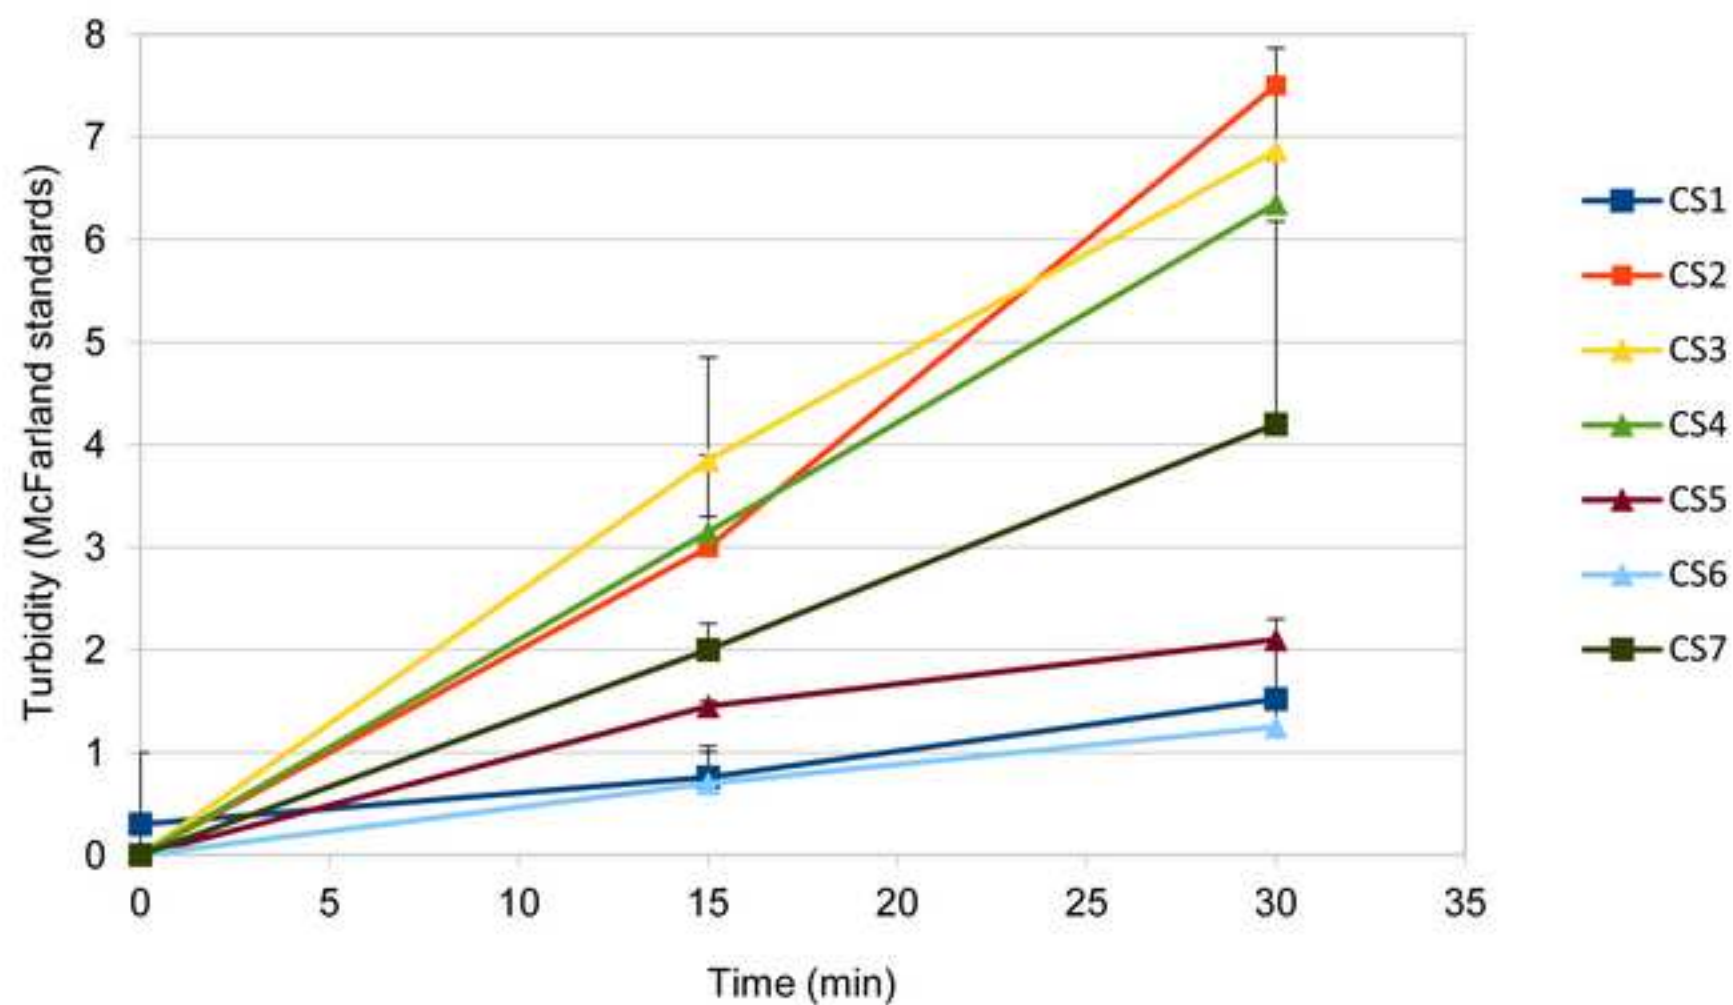
Figure 5  
[Click here to download high resolution image](#)

425 **Figure 5.** Turbidity of different enzymatic Cleaning Solutions (CS) using the McFarland standard  
426 (each sample was tested in triplicate).

Tracking the cleaning protocol with turbidity measurements was a quick and easy way to obtain immediate information about the process (Figure 5). At the beginning, the cleaning solution was translucent (0 McFarland units), but during the cleaning protocol it became turbid. During the agitation stages (Figure 2B), the water was full of detached pieces of fouling. Analyzing the turbidity is a simple index of the progress of the cleaning process, helping with optimization of this. Van Asselt et al. (2002) monitored the real-time turbidity by spectrophotometry of a cleaning solution to test the removal of protein fouling in an automated CIP system. Fickak et al. (2011) used the turbidity and conductivity measurements of the rinsing step to indicate the efficiency of the cleaning process completion.
