Evaluating the suitability of granular anammox biomass for nitrogen removal from vegetable tannery wastewater

Supplementary Material

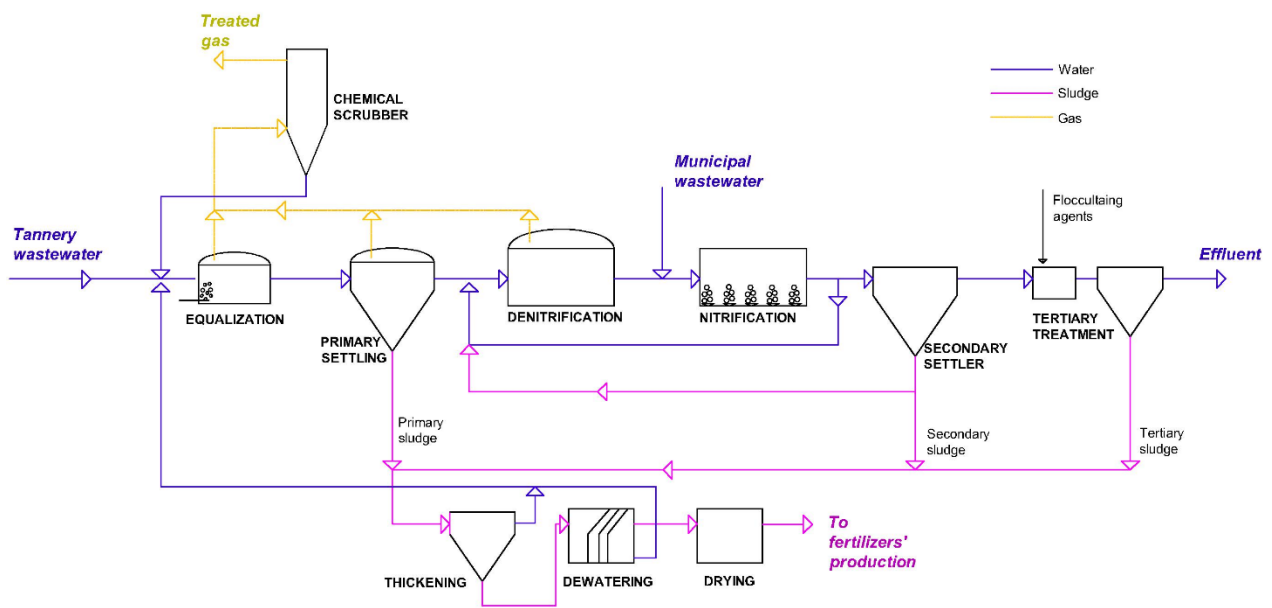
Figure S.1 Current configuration in the tannery wastewater treatment plant managed by Consorzio Cuoidepur S.p.A. (San Miniato, PISA, IT).

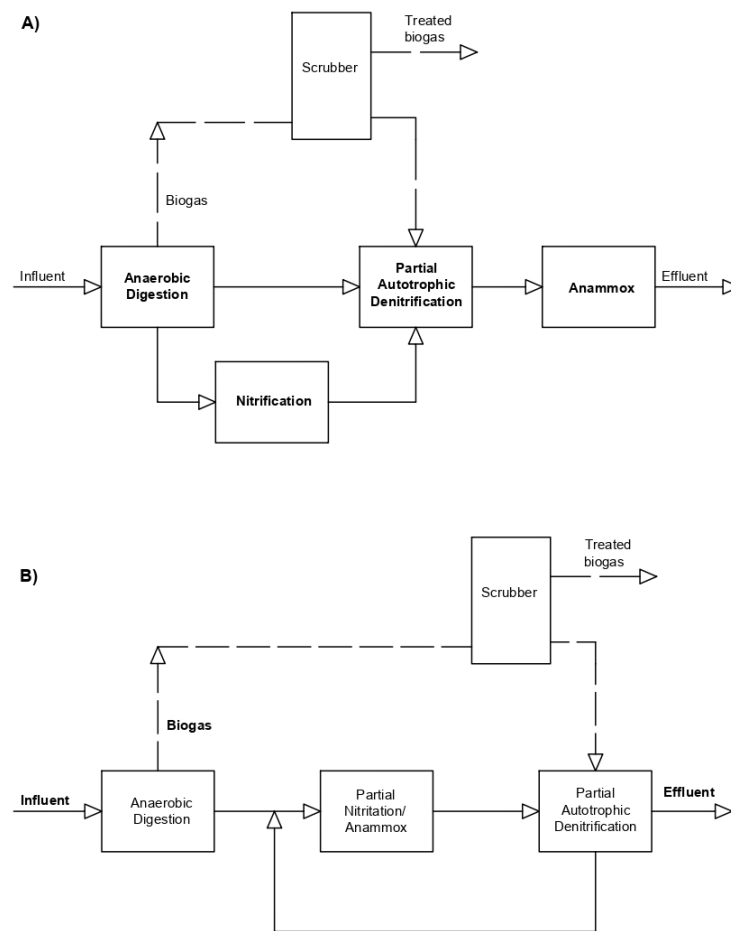
Figure S.2 Possible configurations for innovative treatment trains of tannery wastewater, integrating Carbon, Sulphur and Nitrogen cycles.
